**Massachusetts Department of Environmental Protection**  
Bureau of Resource Protection – Watershed Permitting Program  
**Sanitary Sewer Overflow (SSO)/Bypass**  
**Notification Form**

Hull, MA WPCF

## Unauthorized Discharge Summary 10 Rockaway Ave [07-30-18]

# 10-12 Rockaway Ave

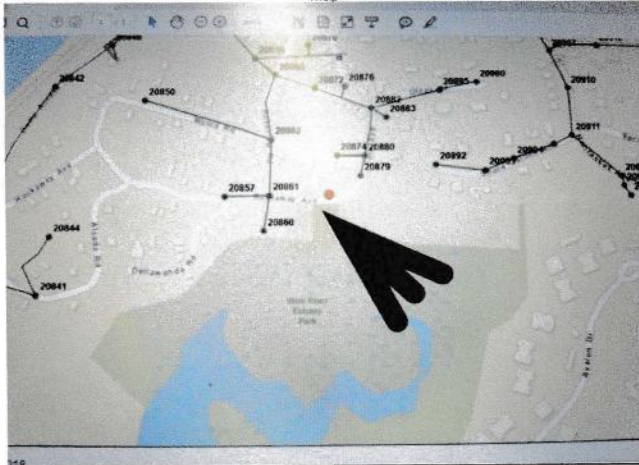
Map

10 Rockaway Ave [red dot]

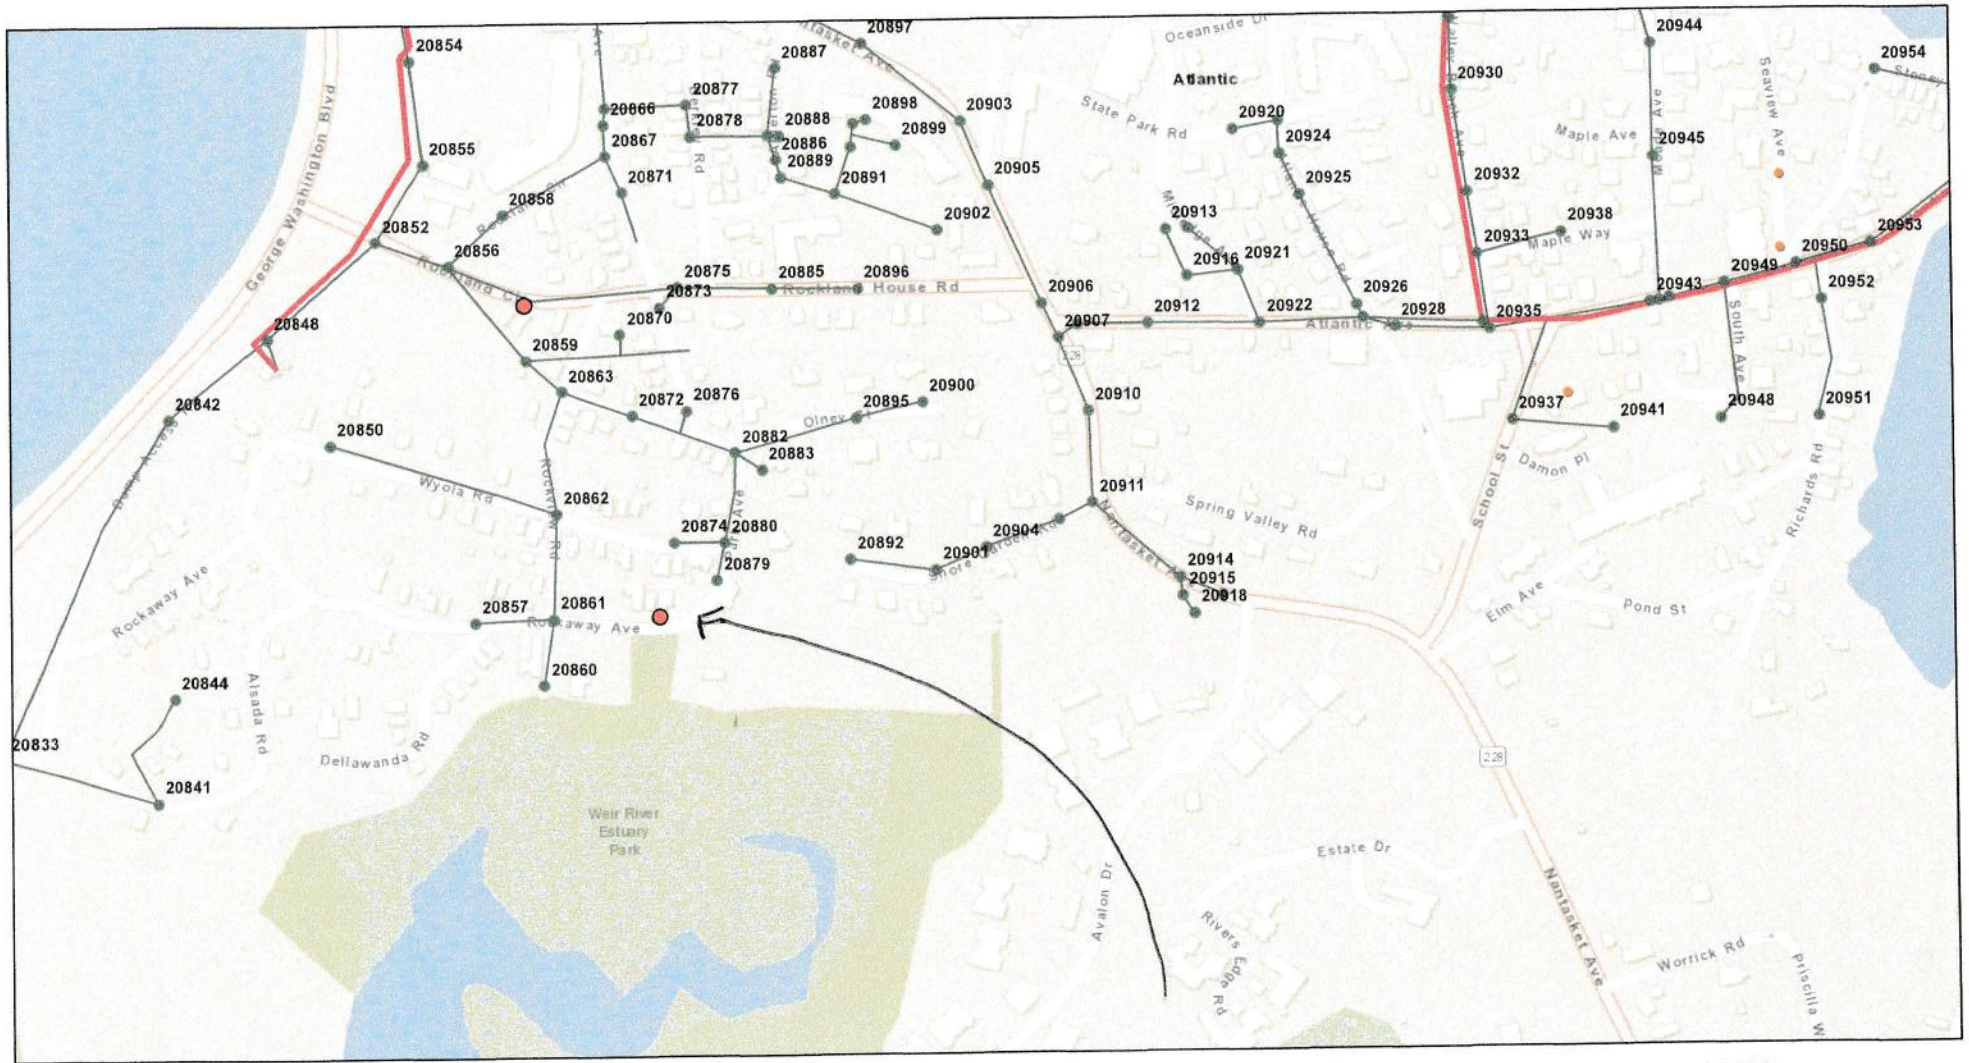
This email is to report a sanitary system overflow [SSO] that occurred yesterday at 10-12 Rockaway Ave. The SSO was the result of a failed grinder pump that services two homes. The pump failure caused the pump chamber to fill up and spill out onto the ground. The release was estimated at less than 40 gallons.

Lime was applied to the areas where sewage leaked out onto the ground. The failed pump was replaced.

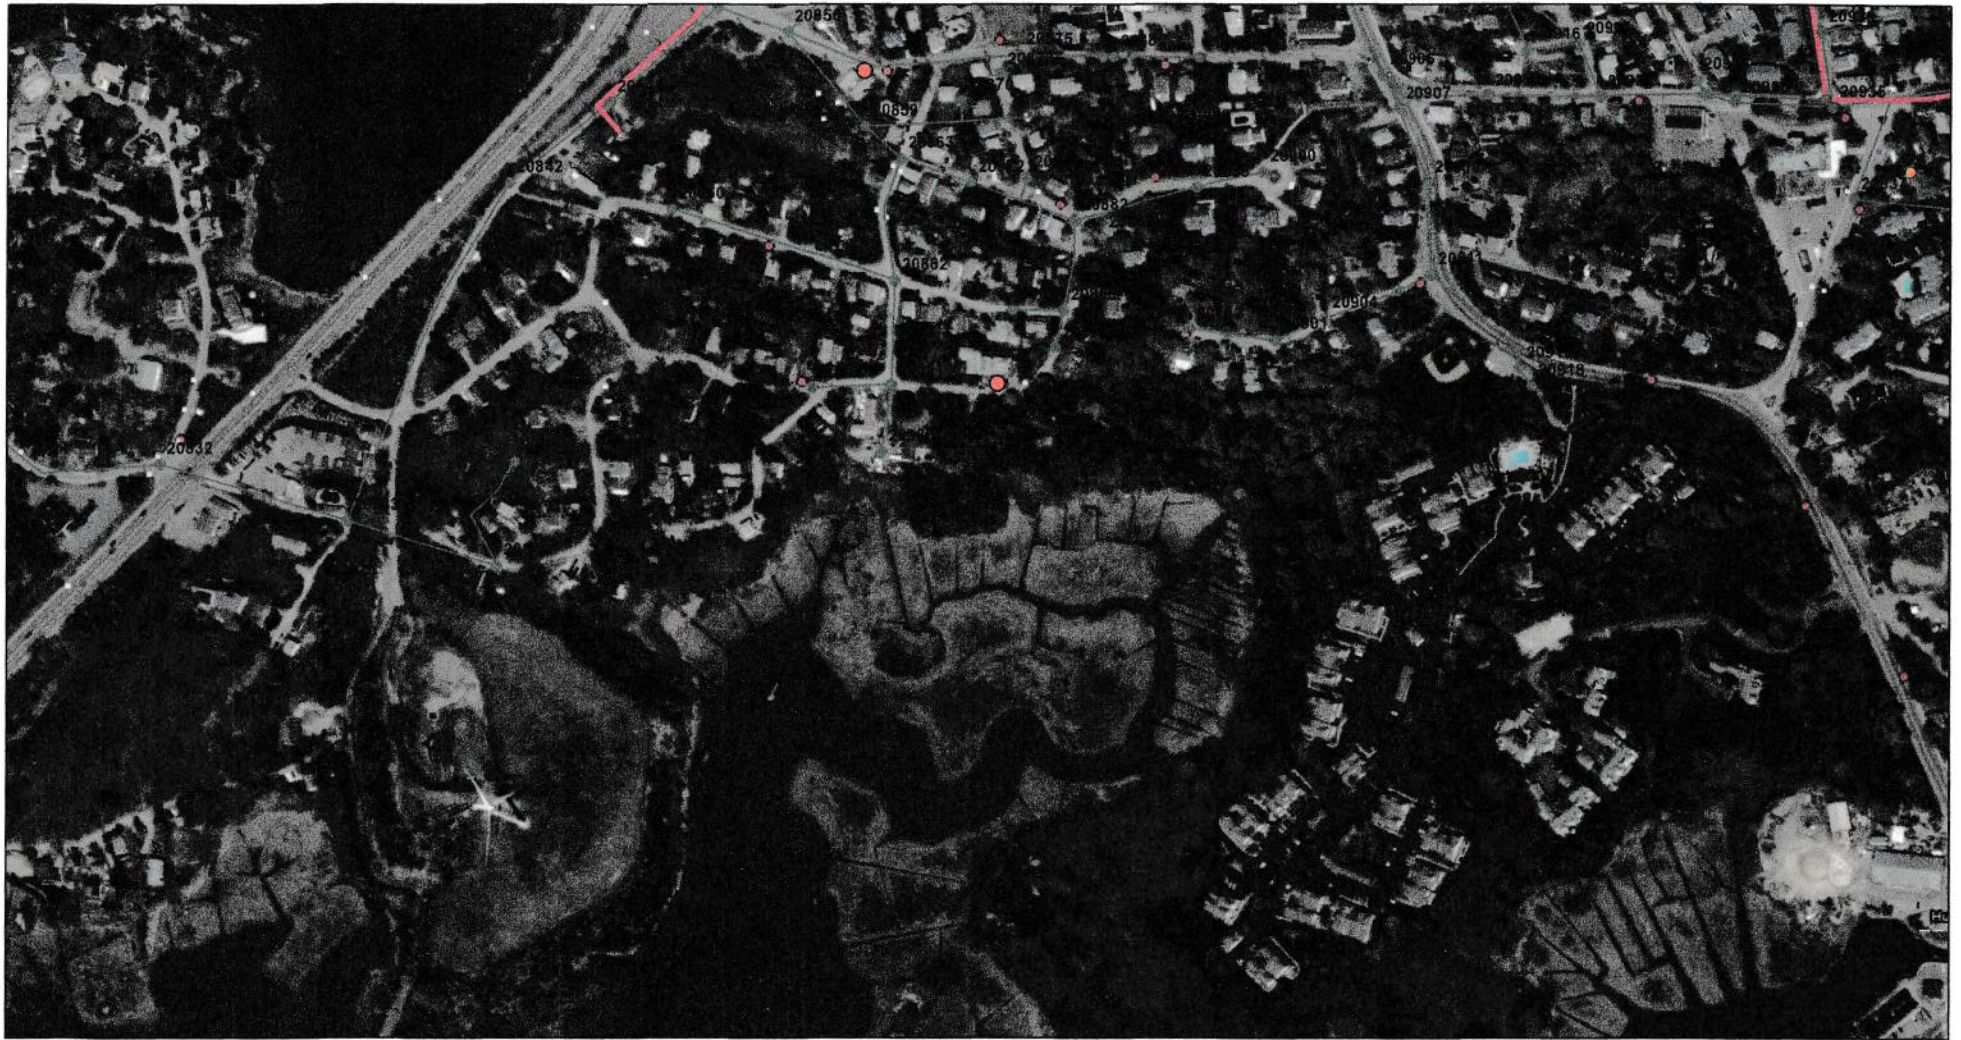
# 10-12 Rockaway Ave

If caused by a blockage, identify the type of blockage (e.g., grease, rags, debris);	<i>NA</i>
If caused by a mechanical, electrical, or structural failure, the date of the last inspection, maintenance, or repair of the failed asset;	<i>NA</i>
Did the release reach any portion of the Town's Municipal Separate Storm Sewer System ("MS4").	<i>Release made it to MS4 catch basin, but <u>did not</u> travel any further than this structure.</i>

<b>If the release occurred to the ground, provide the location of the nearest down-gradient catch basin and the name of the receiving water to which the catch basin discharges;</b>	<i>Nearest down-gradient catch basin just past #10 Rockaway Ave on same side of road as the residence. It is believed that the Wier River Basin is receiving water that this catch basin discharges to. It should be noted that NO DISCHARGE from this catch basin occurred.</i>
<b>Did the release reach a wetland or surface water? If so, include the name and exact location where?</b>	<i>No</i>
<b>Measures taken to minimize the volume and duration of the unauthorized discharge;</b>	<i>Noted above and on SSO form. Diverted/diked to minimize, and vacuumed up from ground surface. Vacuumed out catch basin contents.</i>
<b>Measures taken to clean the area where the unauthorized discharge occurred;</b>	<i>Lime applied to all areas;</i>

<b>Corrective actions taken to prevent reoccurrence of unauthorized discharges at the same location;</b>	<i>New pump was installed on 7/30/18</i>
<b>Date of the last unauthorized discharge in the same general location;</b>	<i>NA</i>
